GEOTECHNICAL STUDY AREA G14**SCARBOROUGH, NORTH YORKSHIRE, UK**

1. INTRODUCTION**1.1 Background**

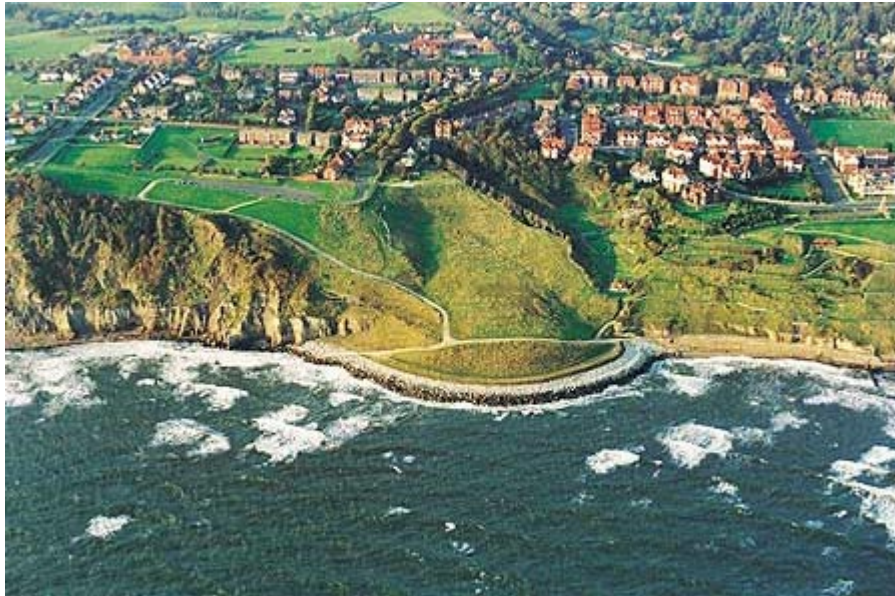
Plate G14 Holbeck Hall landslide – after stabilisation (Scarborough BC)

The most recent large scale event occurred in June 1993 where a major landslide occurred on the 70m high coastal cliffs in front of the Holbeck Hall hotel. Over 60m of the cliff was lost overnight, leaving the hotel in a very dangerous position as cracks began to develop in the building. A further 35m of cliff collapsed over the next 3 days undermining the hotel which gradually toppled over the cliff edge. In addition to causing the loss of the hotel, the landslide overwhelmed the existing coastal defences, burying them beneath a large debris lobe which extended over 100m across the shore platform. Subsequent engineering works at the site have involved constructing replacement coastal defences and slope stabilization works (Plate G14).

A rock armour revetment with a crest elevation of approximately 6mOD has been placed as protection of the landslide toe. As described earlier, the slopes have been regraded and drained to improve the stability (Plate G14). A recent condition survey undertaken in 1999 revealed the existing sea defences to be in good condition.

- a rock armour revetment placed at the toe of the eroding front of the landslide debris lobe on the shore platform. The design included 30,000 tonnes of rock placed against an inner core of 1 cubic metre heavy duty geotextile bags filled with slip material.
- reprofiling the failed slope to an overall angle of 24° for cut slopes, with the lower slopes filled with the excess material to between 6° and 20°. During construction the surface of the regraded slope was compacted and sealed to reduce infiltration and minimise surface erosion.
- slope drainage, including an interceptor drain at the cliff top, a perimeter drain, localised piped drains and counterfort drains.

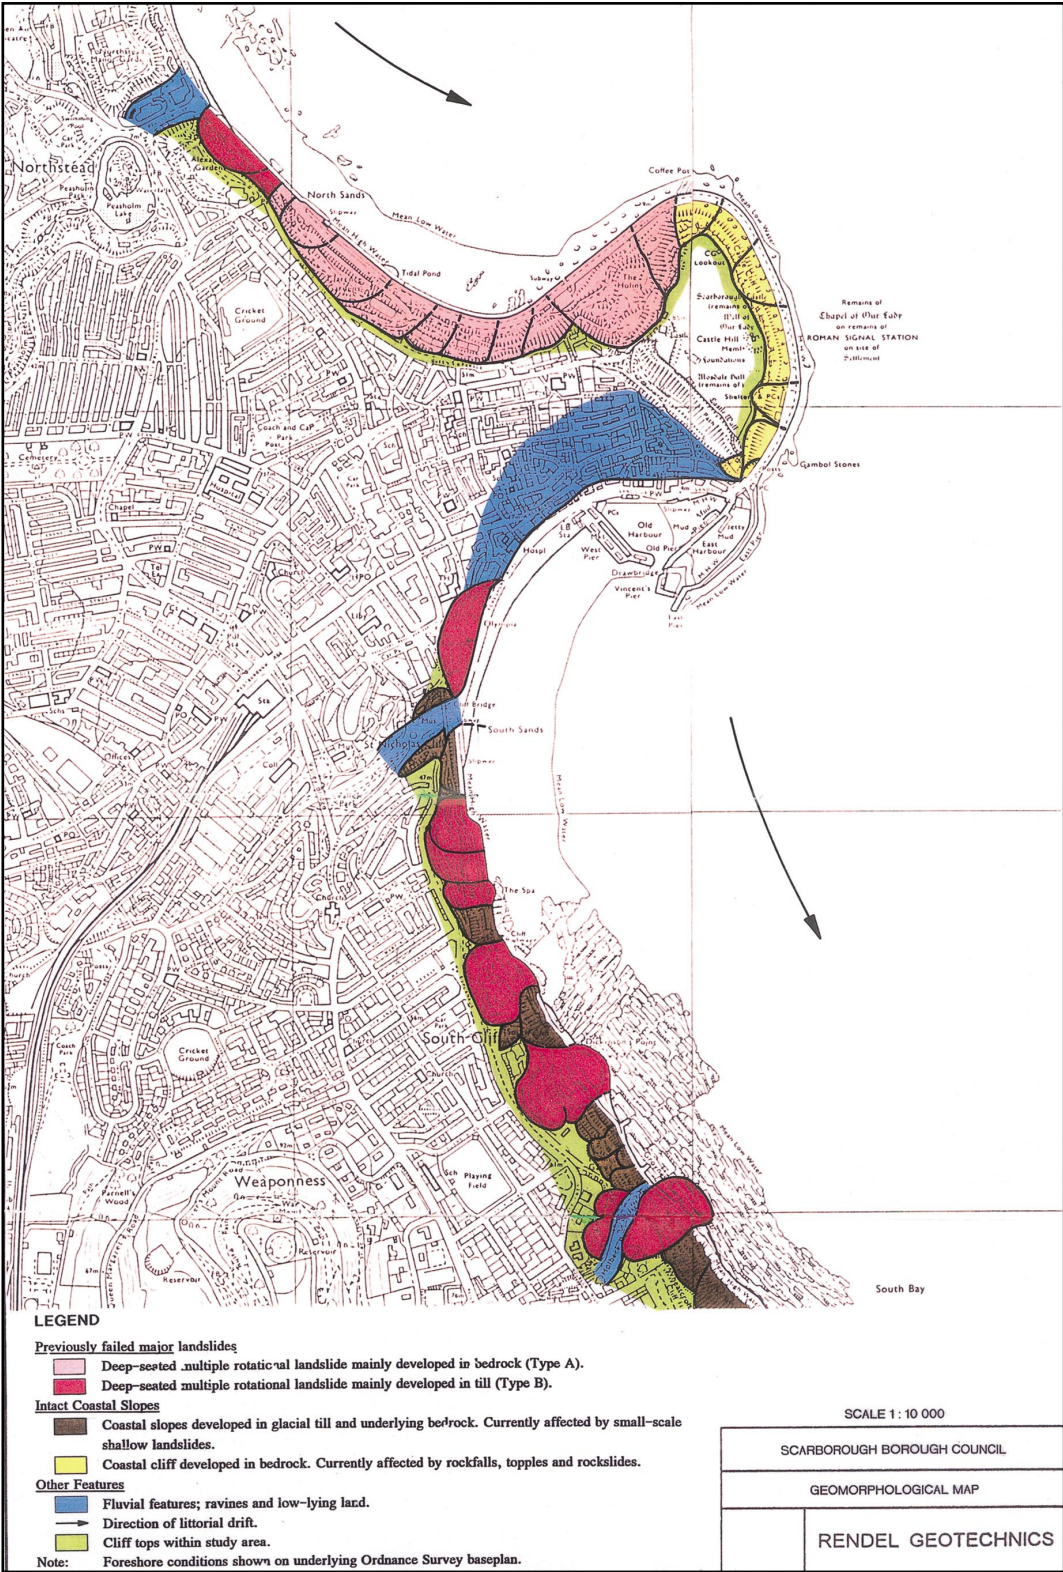
A geomorphological map has been produced which summarises the surface form of the Scarborough coastline (a summary map of Castle Headland and the North and South Bay's is shown in Figure G14.2). This map shows the relative positions of the main geomorphological units i.e. coastal slopes and the characteristic steep-sided ravines that occur at Holbeck Ravine, Valley Road and Peasholm Gaps. These features are all relict valleys cut by fluvial action probably during the Devensian when the melting ice would have given rise to large quantities of meltwater. Under these conditions the valleys would have been formed quickly with rapid downcutting resulting in oversteeped, inherently unstable side slopes.

Figure G14.2 Geomorphological map, Scarborough.

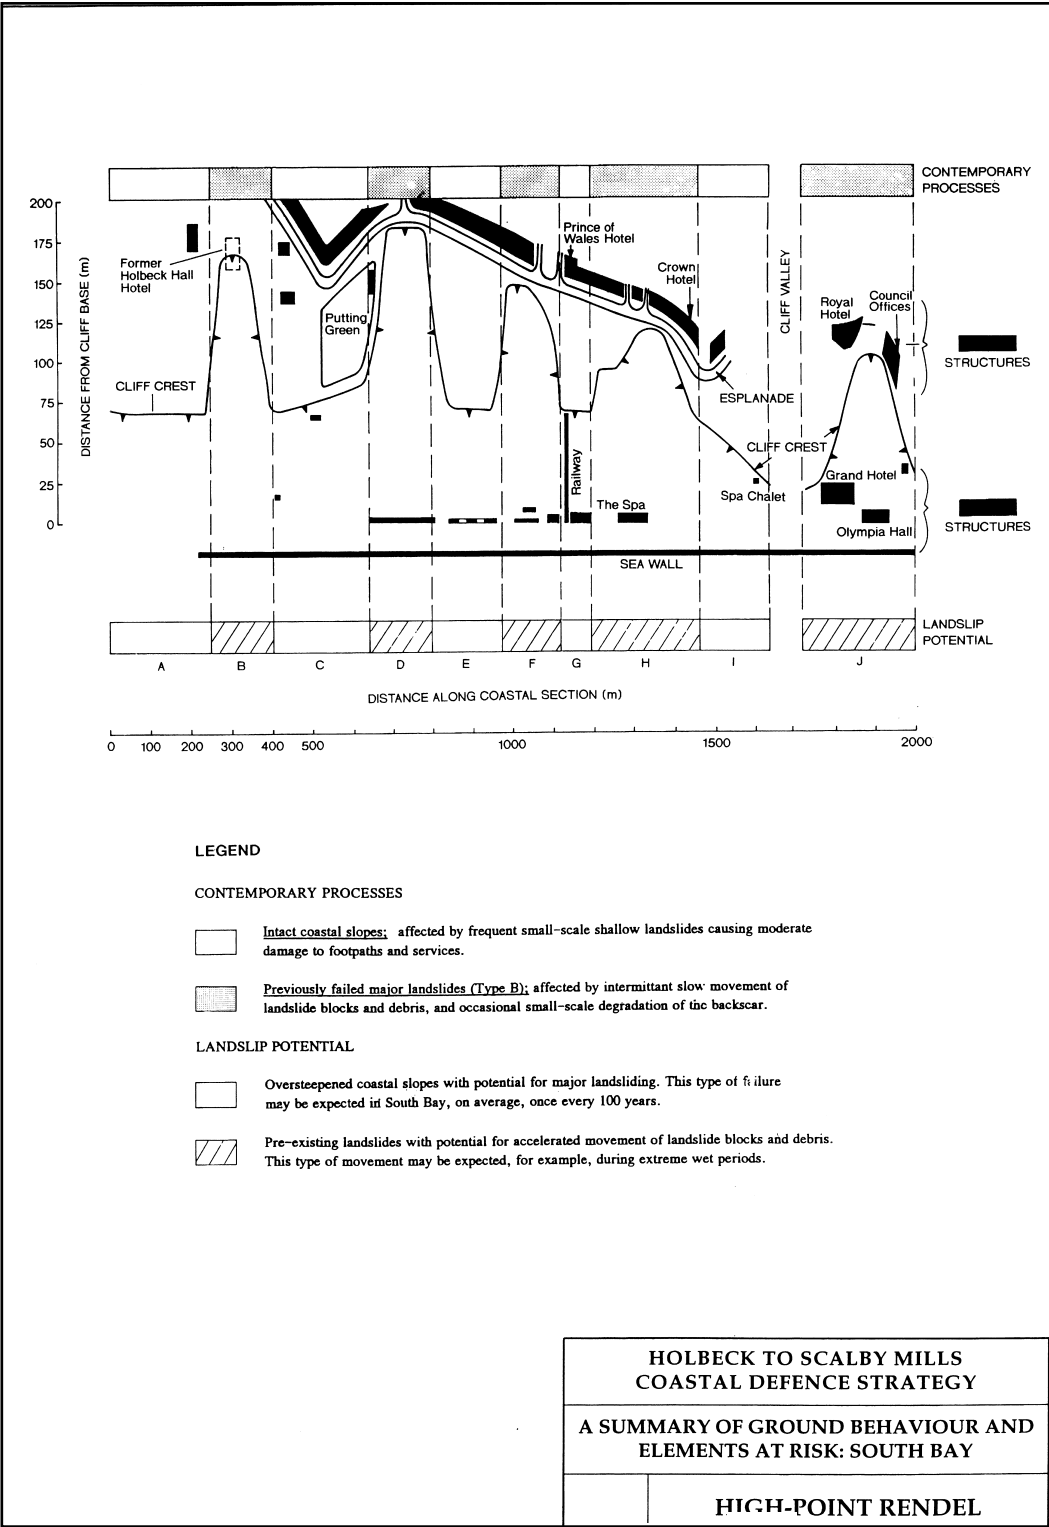
The range of potential problems vary along the coastline, according to the nature and condition of the defences, the exposure to wave attack and the geological setting. Figures G14.3 and G14.4 show the ground behaviour and elements at risk along the coastline of the North and South Bay's, Scarborough.

Figure G14.3 Summary ground behaviour - South Bay, Scarborough.

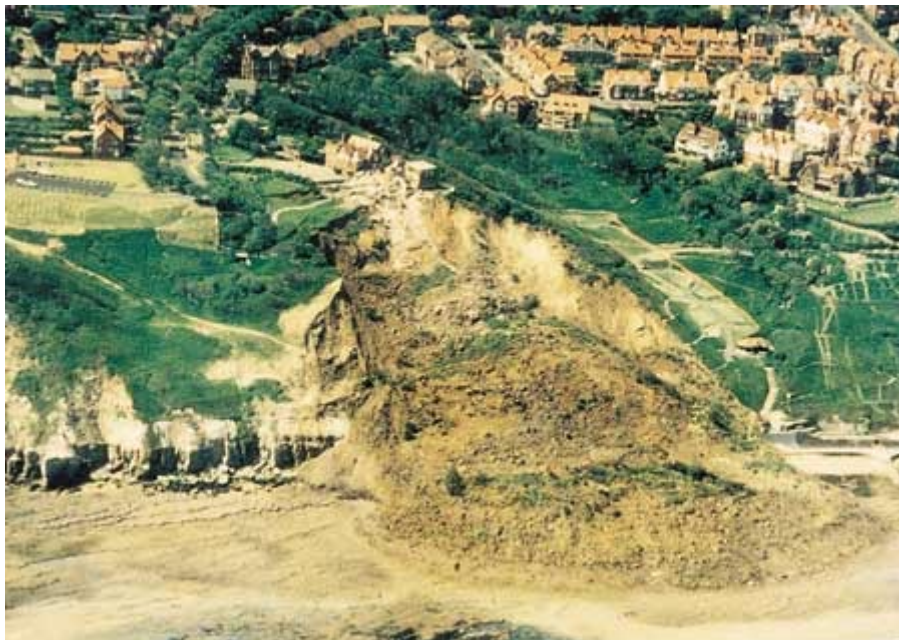
The 1993 landslide involved a complex series of retrogressive movements and overwhelmed the seawall, with a debris lobe extending some 100m across the shore platform (Plate G14c). Failure is believed to have occurred along a composite shear surface developed on:

A characteristic feature of the Holbeck failure was the unusually large and rapid displacement of material. This is likely to be a reflection of the brittleness of the materials along the shear surfaces. This would have resulted in high strain energies being stored in the ground mass prior to failure, and meant that once failure had begun a sudden release of energy occurred, and the mass would only come to rest at a much lower slope angle. The key factors involved in the Holbeck landslide can be identified in Table 1.

Although heavy rainfall in the 6 months preceding June 1993 is believed to have been a major contributory factor, the failure was probably also the consequence of long-term progressive failure of the till and mudstones. Progressive failure has been observed in glacial tills elsewhere and is an indirect effect of marine erosion which unloads the cliff and induces shear stresses in the ground mass, leading to strain-softening as the in situ materials expand as a result of the removal of confining lateral stresses. If the strains are concentrated at a particular horizon (e.g. a bedding plane) then the available shear strength of the material may be exceeded and a shear surface forms. This weakened surface can then lead to the development of a deep-seated slide as the shear surface propagates upwards the cliff top. Evidence of the possible effects of progressive failure of the material at Holbeck Hall was identified in the boreholes on the cliff top, behind the landslide where polished slickensided surfaces were found in both the stiff, plastic silty clay till and the mudstones.

Plate G14c *View of the Holbeck Hall landslide*
